REPORT OF INVESTIGATION
(Underground Coal Mine)

NONINJURY COAL MINE OUTBURST (BOUNCE) ACCIDENT

L. S. Wood Mine (ID No. 05-00300)
Mid-Continent Resources, Inc.
Redstone, Pitkin County, Colorado

September 9, 1980

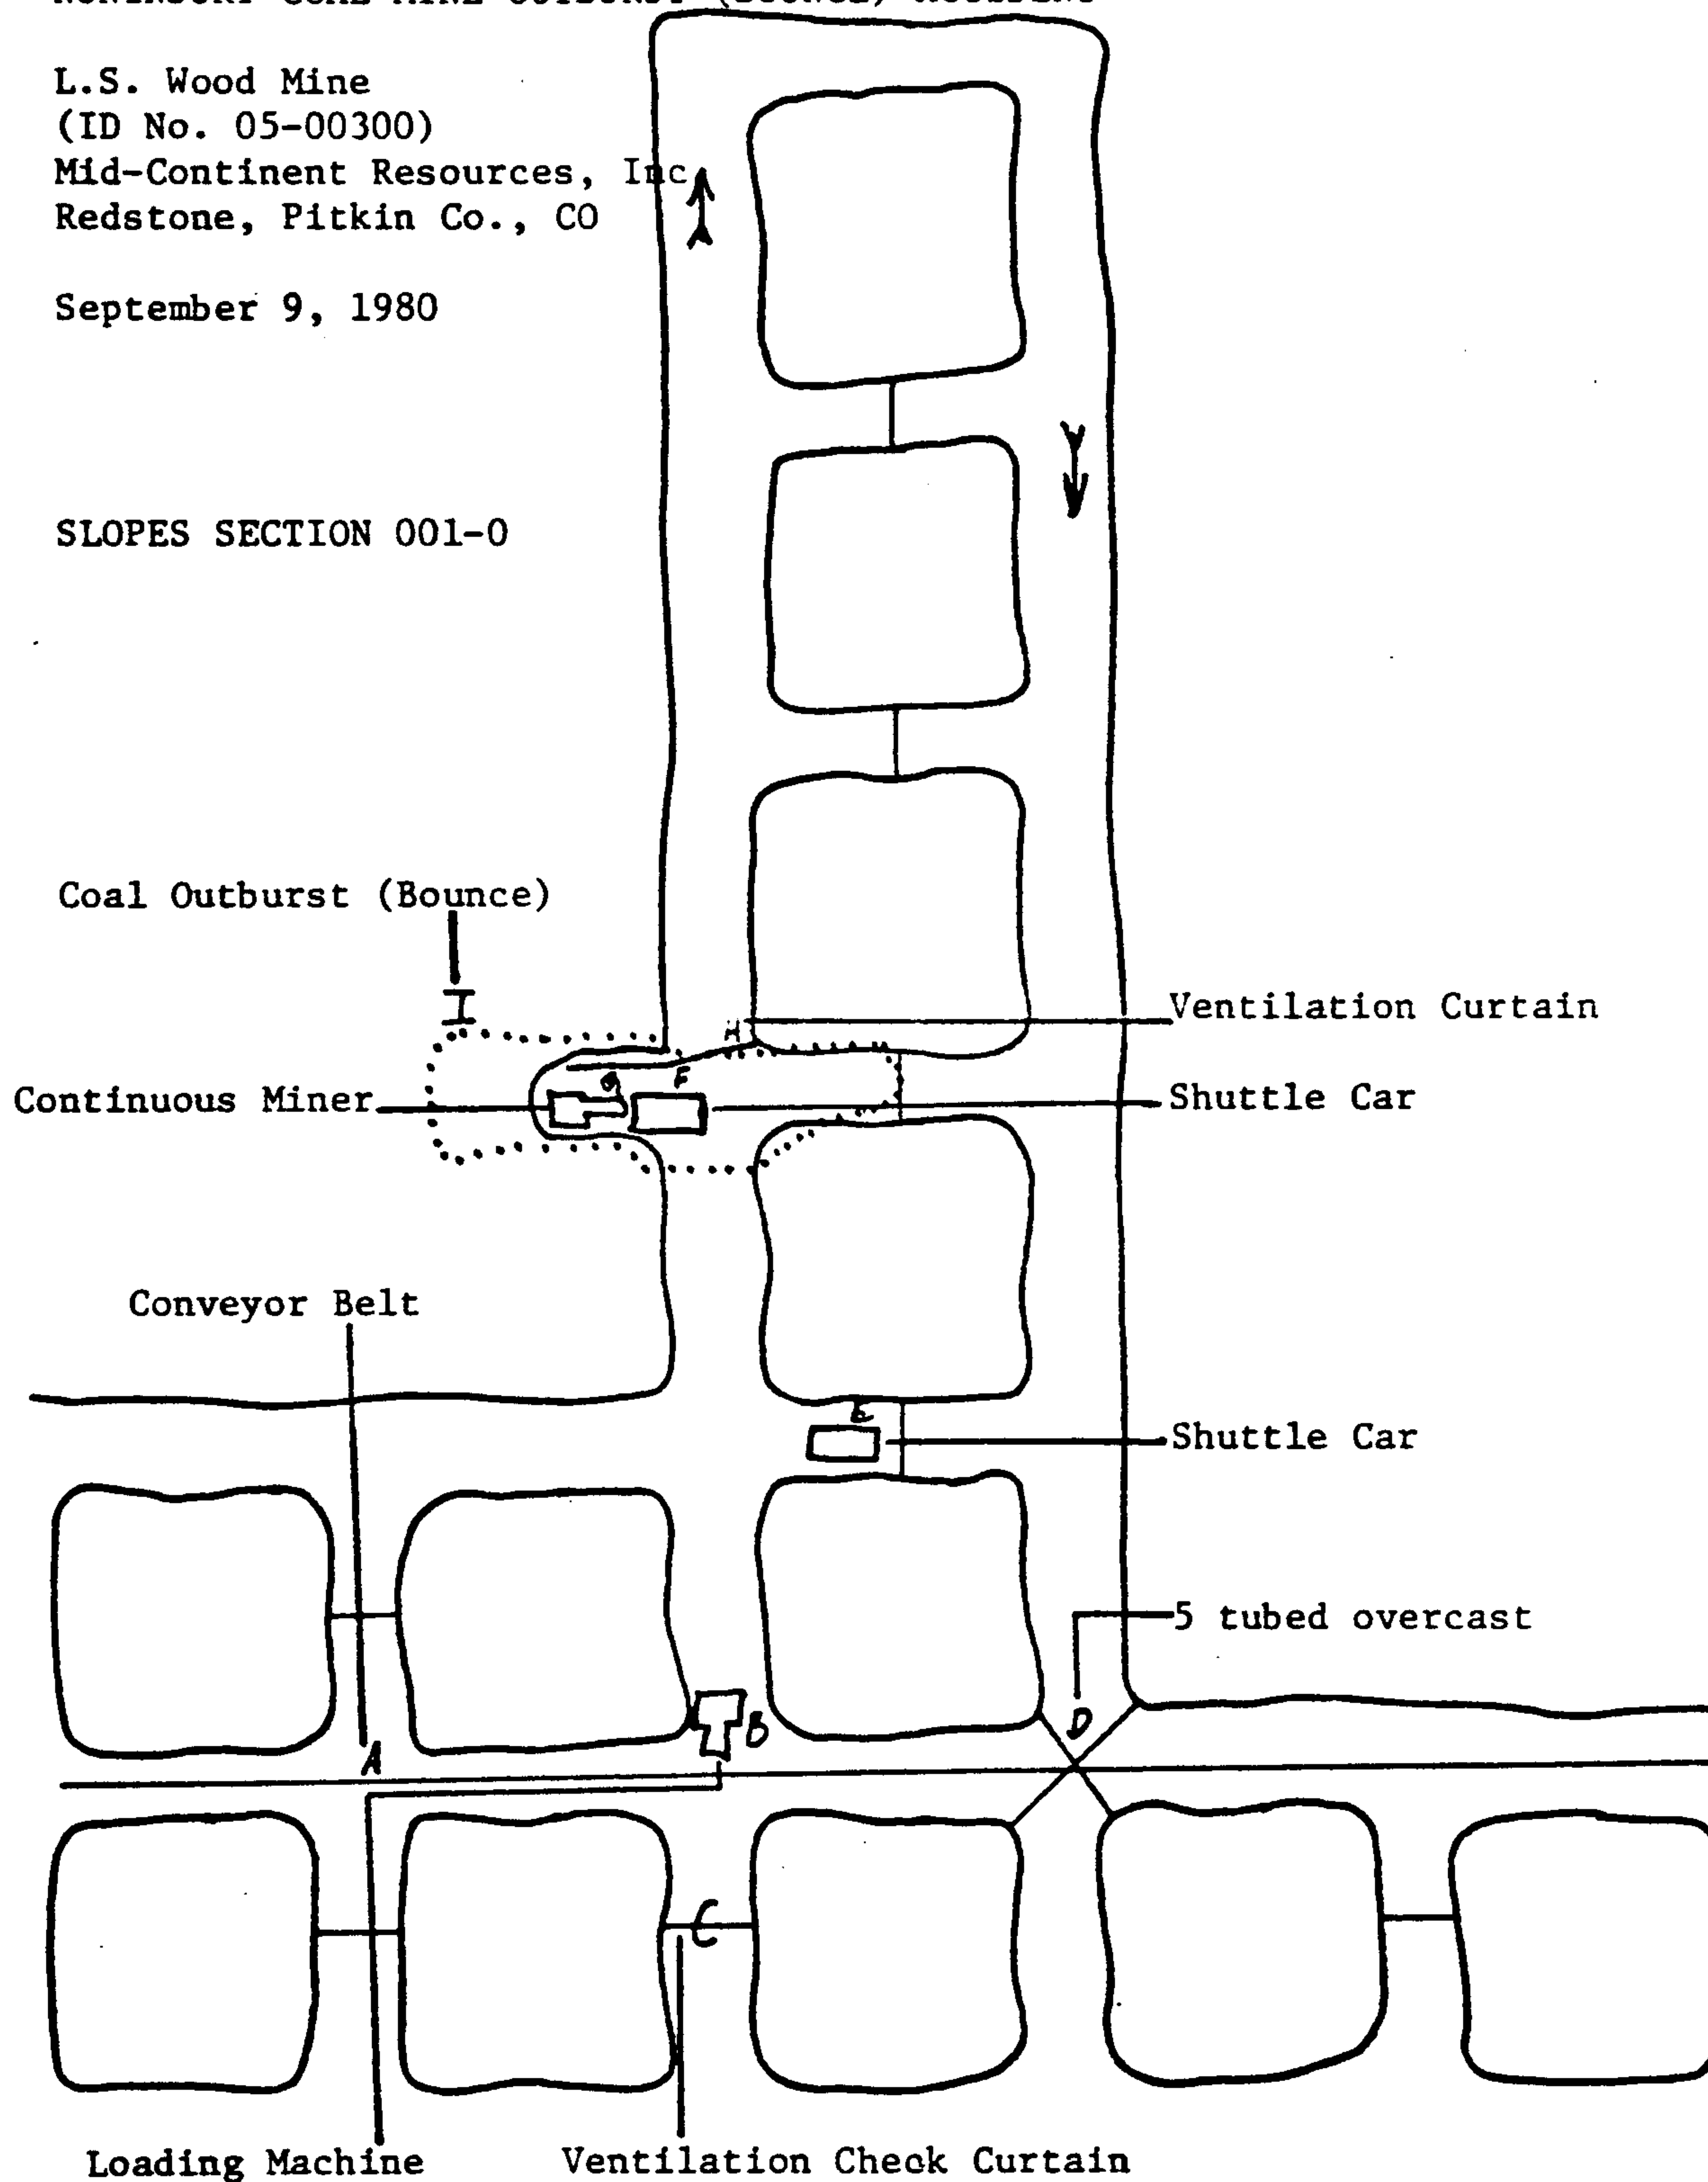
SLOPES SECTION 001-0

1. The coal outburst caused the withdrawal of miners and disrupted regular mining activity for more than an hour.
2. The coal outburst affected ventilation.
3. High concentrations of methane gas were liberated during and after the outburst.
4. The crosscut measured 18 feet 5 inches wide, 7 feet 4 inches high, and approximately 40 feet long prior to the outburst. After the outburst, it measured 26 feet 9 inches wide, 7 to 14 inches high, and approximately 75 feet long.

5. The outburst blew out of the crosscut and impacted on the north rib and permanent stopping located in the crosscut between No. 5 and No. 6 slopes.
